LAKE SOPHIA DAM

NDI I.D. PA-0078

PHASE I INSPECTION REPORT  
NATIONAL DAM INSPECTION PROGRAM

LAKE SOPHIA DAM  
NDI I.D. PA-0078  
DER I.D. 058-126  
MARCH 23, 1981

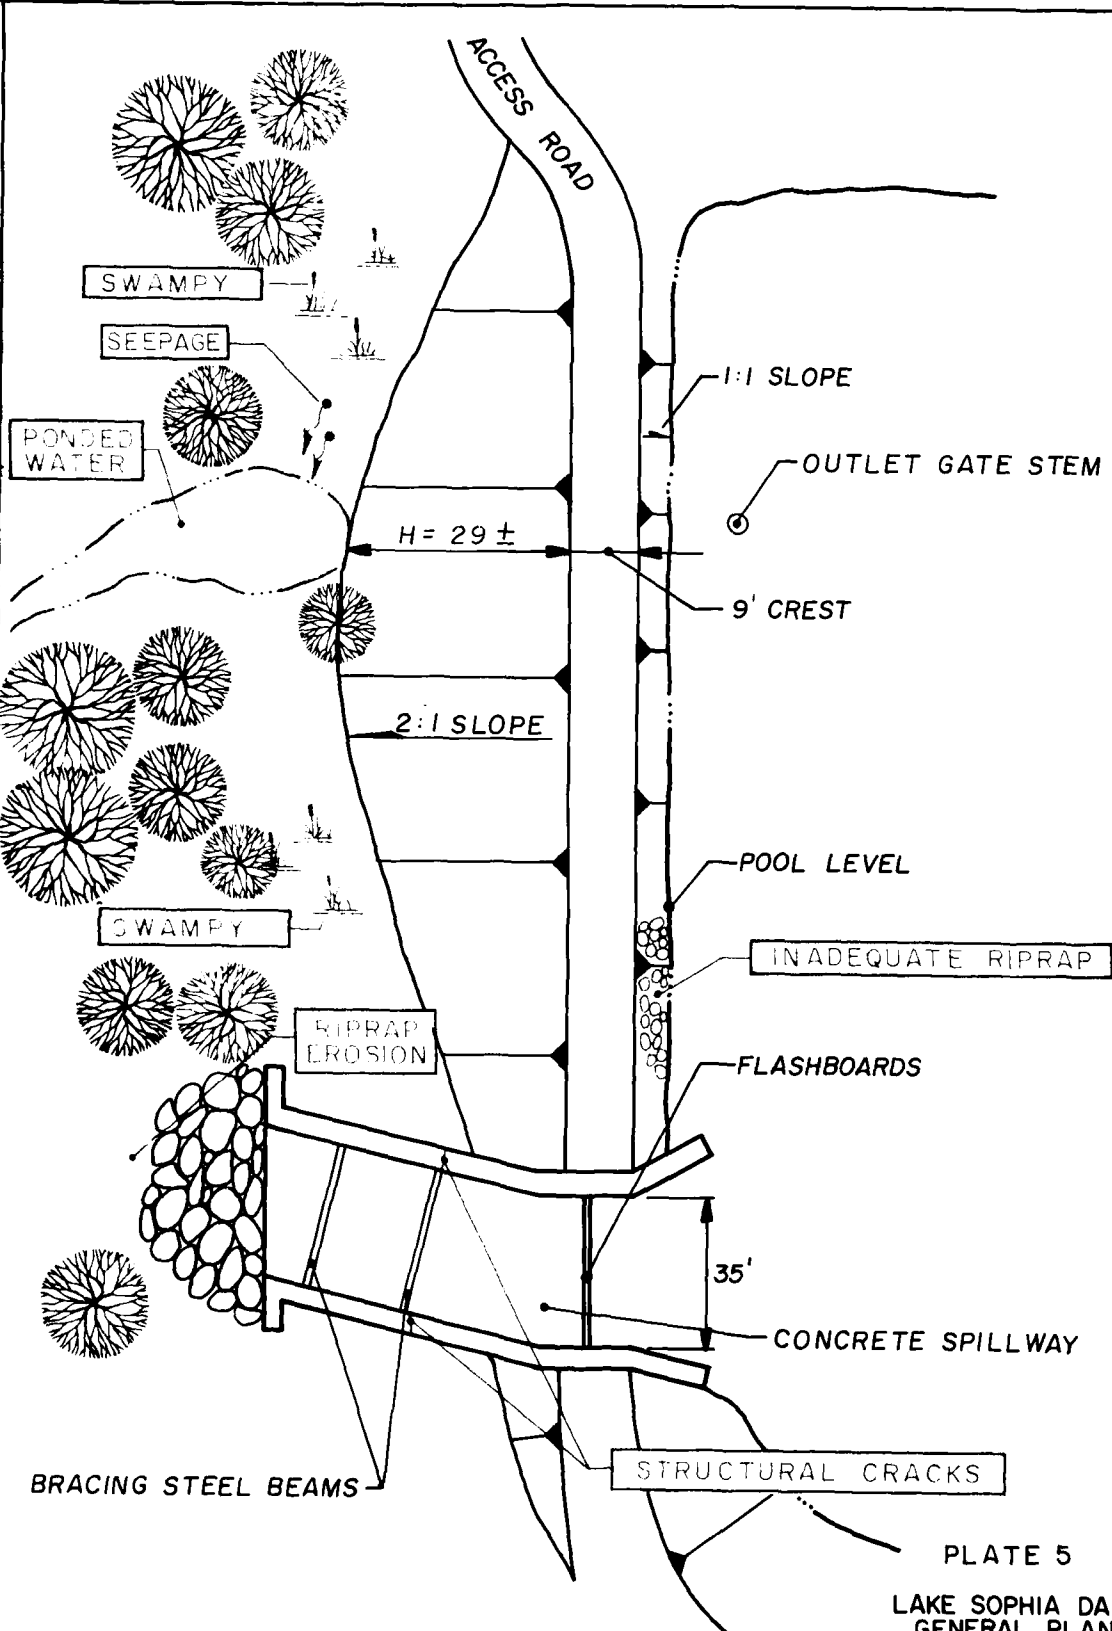
PLATE 5  
 LAKE SOPHIA DAM  
 GENERAL PLAN  
 FIELD INSPECTION NOTES  
 FIELD INSPECTION DATE: MAR. 23, 1981

In general, the condition of the embankment is considered to be fair. No major signs of distress such as slumps or cracks were found. However, extensive swampy areas were observed below the junction of the embankment with the abutments, which raised concern as to the effect of this apparent underseepage on the continued stability of the dam. A seepage in the amount of 10 to 20 gallons per minute was found to be associated with the swampy area on the right abutment. Precipitate was observed in the right abutment seepage. No measurable seepage was observed in the left abutment swampy area. Further, a portion of the toe of the dam was submerged by a pond formed by debris and a beaver dam blocking the outlet pipe discharge channel. This condition precluded inspection of the vicinity of the downstream end of the outlet pipe for possible seepage. Some shoreline erosion was observed along the upstream slope. Riprap on the upstream slope has partially dislocated and is not effective for controlling erosion, due to wave action.

VISUAL EXAMINATION OF	OBSERVATIONS	REMARKS OR RECOMMENDATIONS
JUNCTION OF EMBANKMENT AND ABUTMENT, SPILLWAY AND DAM	No problem observed.	
ANY NOTICEABLE SEEPAGE	Swampy areas below the toe of the dam along both abutments. See Plate 5 for location.	Further investigation of this condition is recommended.
STAFF GAGE AND RECORDER	None	
DRAINS	None observed.

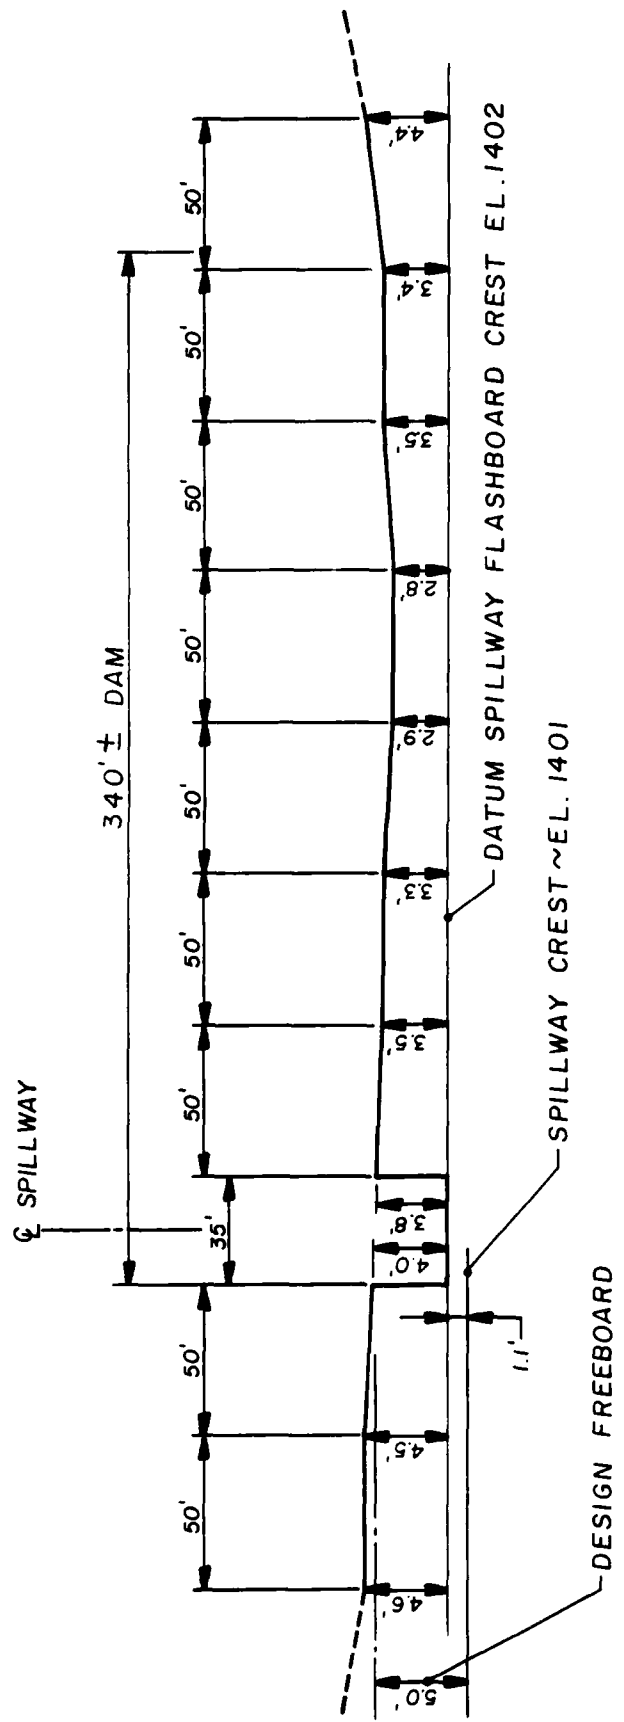
# **DAM CREST PROFILE** (LOOKING DOWNSTREAM)

The top of the dam was surveyed relative to the spillway crest elevation and the center of the dam was found to have apparently settled. While the design freeboard for the dam was 4 feet, the field survey indicated a freeboard of 2.8 feet between the low spot near the right embankment and the normal pool level.
